Manhole Inspection Summary

Manhole # S43GG_044MH

Insp Date: **9/2/09 11:11 AM**

Location Address: **LLEWELYEN AVE**

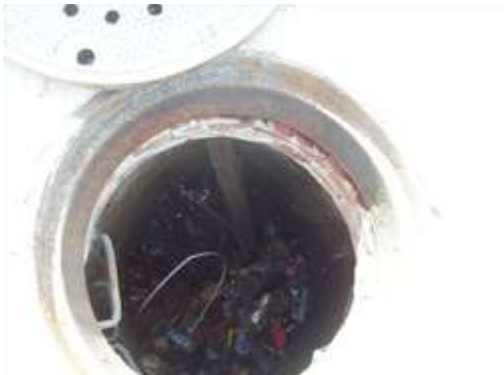
Top View

STORM DRAIN COVER

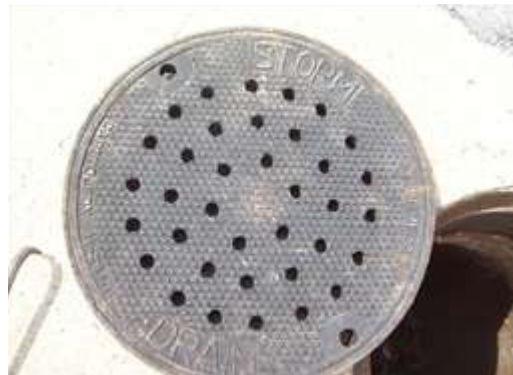
Condition: **Broken**

STORM DRAIN COVER AND CRACKED

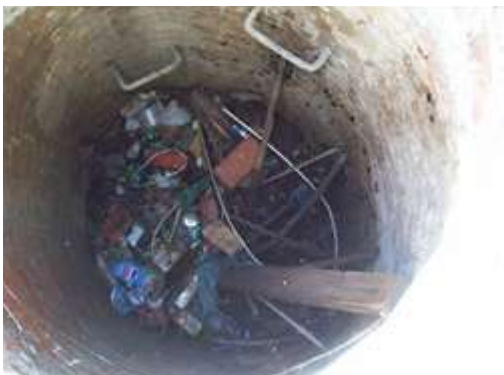
Defect 1

Inspection ☒ **Is Incomplete** Rating: **5) Immediate Attention Required**

Debris Too Heavy and Pipe Pictures Cannot Be Taken

Condition: ☐ Sound ☐ Cracked ☐ Root Intrusion ☐ Deteriorated ☐ Leaks ☒ **Debris**

DEBRIS ALL OVER BOTTOM OF MH
